EVALUATION OF HYDRAULIC FLUIDS  
FOR USE IN ADVANCED SUPERSONIC AIRCRAFT

FOURTH SEMIANNUAL REPORT

March 24, 1967

CONTRACT NAS 3-7263

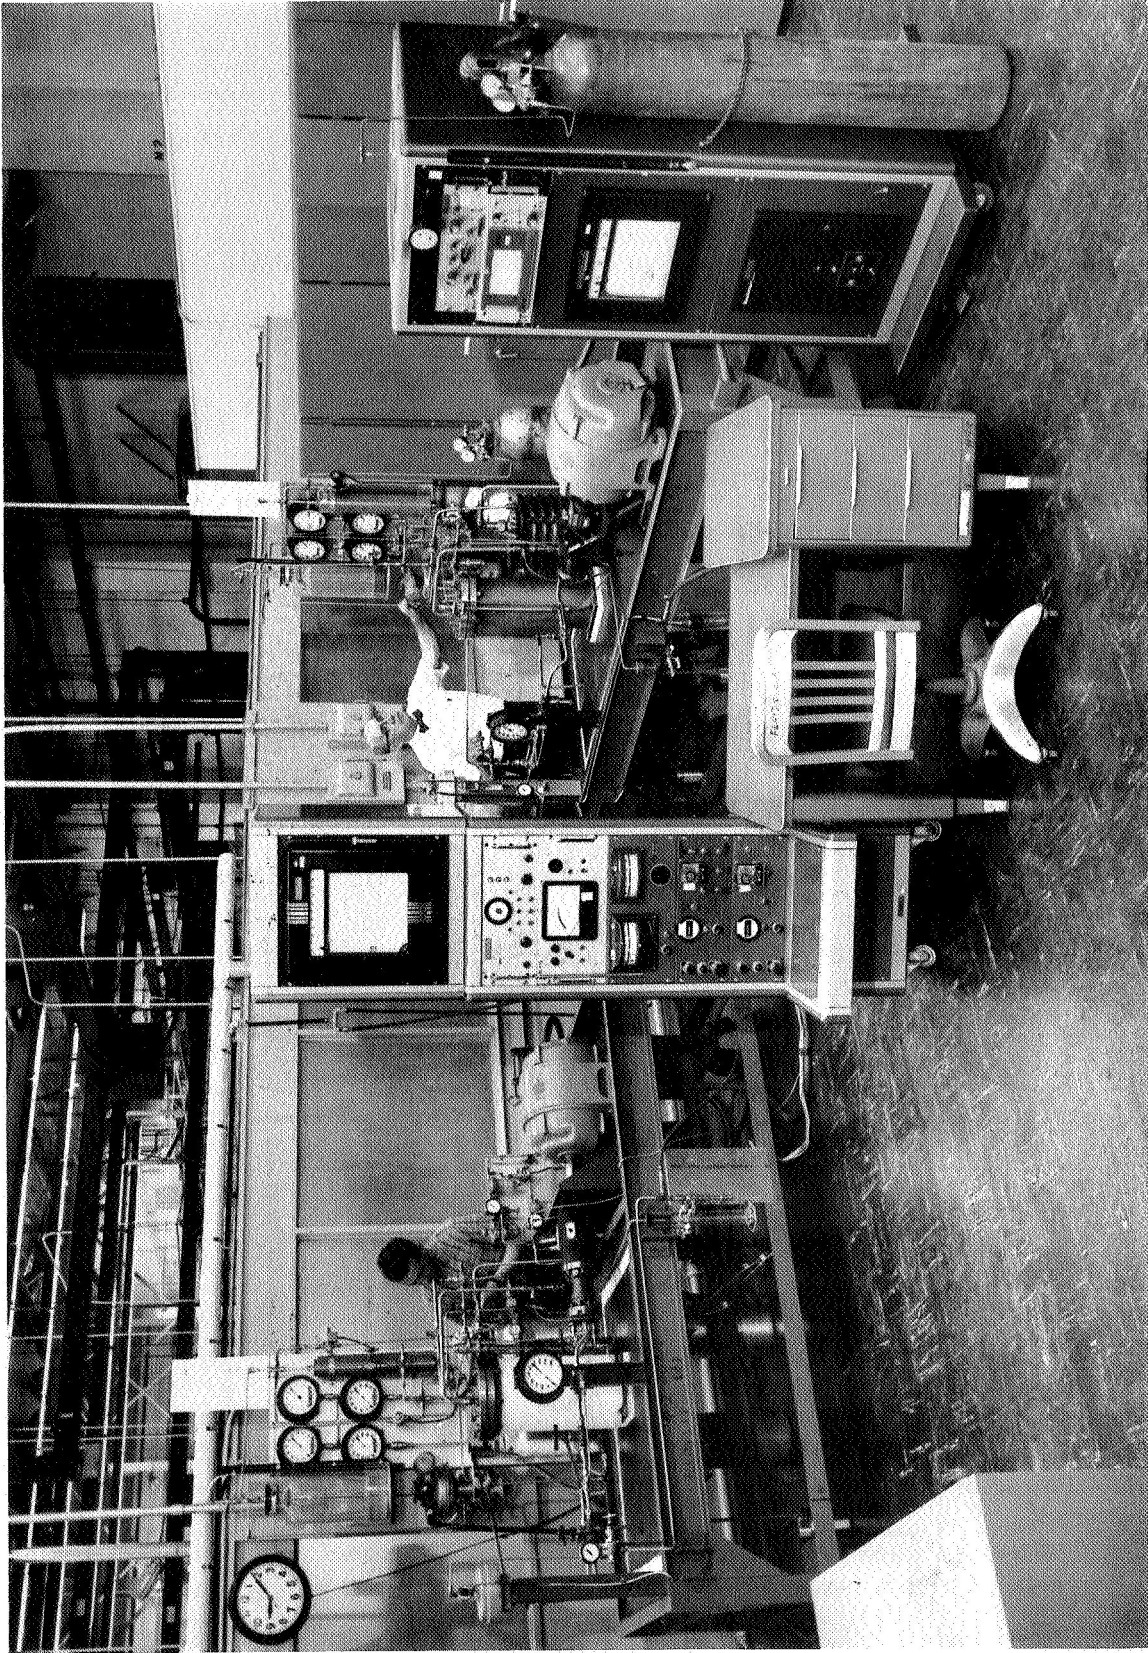
RD 5580

Figure 4. Photograph of Two Pump Rigs and Instrument Console

The pump loop is shown schematically in Figure 3. A photograph of the two identical pump rigs and the instrument console is shown in Figure 4. The hydraulic system of each rig comprises: a reservoir, pump, filters, load valves, heat exchanger, expansion tank, and accumulator. Instrumentation includes thermocouples, pressure gages, flow meter, pressure limit switch, and torquemeter. The fluid capacity in the system proper is about 5 gallons.

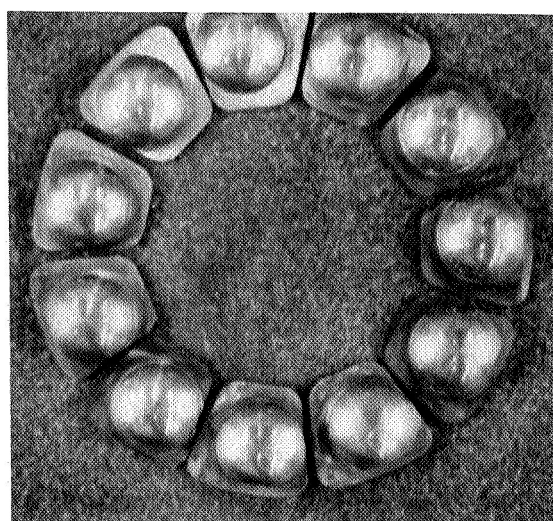
Figure 14. K-82 Shoes and Thrust Bearings and K-96 Swash Plate  
As Received in Pump S/N X-1800

Figure 14, as received in pump S/N X-1800. Small fractures occurred during broaching of the spline, Figure 14c, and during the drilling of the lubrication holes in the swash plate, Figure 14d. The material of the swash plate is very brittle and easily susceptible to chipping at sharp edges or corners.
